# PART WORKS

Bolt Hole Corrosion and Fatigue Damage Repair in Hybrid Structure
Presented by Jude Restis & Dr. Matt Kokaly

Dec 2022

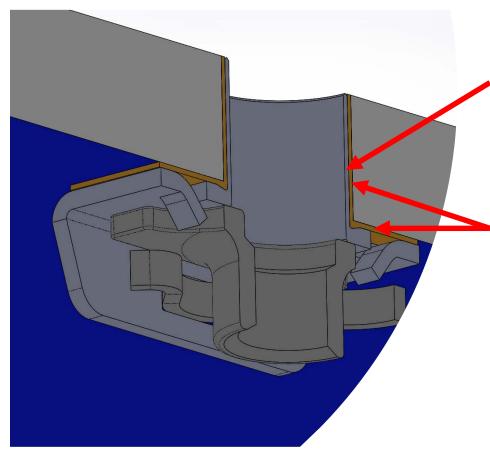
### PartWorks Repair - Rivetless Nut Plate

#### Thin wall

- CRES Retainer barrel
- Minimizes material removal
- Maximizes e/D
- Maximizes cold expansion to the structure

#### **Adhesive**

- Maximizes torque-out and push out
- Galvanic barrier
- Minimal surface preparation

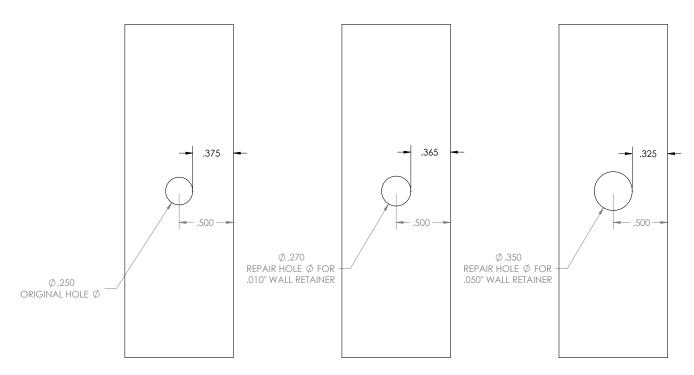
### Preserve Edge Margin

Status Quo e/D = 1.43

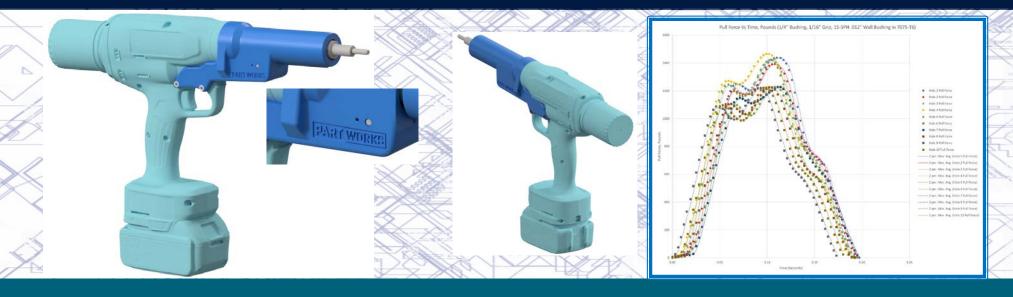
### Process Verification - In Tool Measurement and Feedback

- Cold Expansion process parameters and pull-force documented in tool
- Pull-force data correlated to:
  - DIC
  - Test data
  - Material properties and geometries
- Good / Bad feedback provided to operator

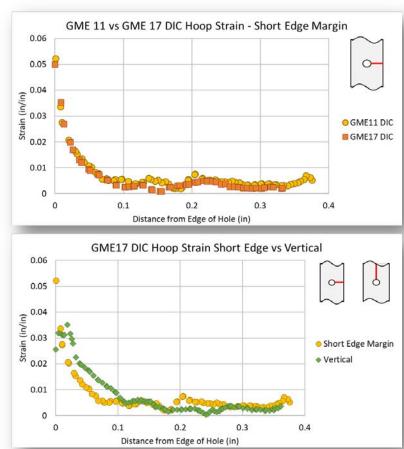
#### Residual Strain Visualization with DIC

- Image Capture: Before, during and after repair
  - On-tool image capture
- DIC used to correlate residual strain with FEA
- Will also be correlated to X-Ray diffraction

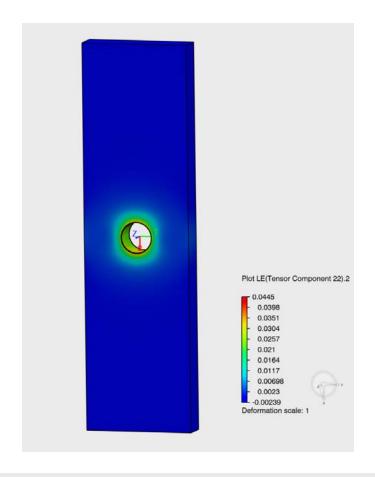
### FEA - Process Simulation

- 3-D Pull Through Model
- Elastic-Plastic Properties of the Material
- Contact Modeled
- Explicit Method

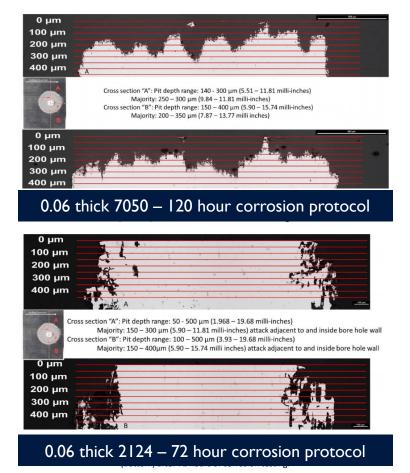
### Corrosion Protocol Development

NaCl and NaAlO2 solution

- Dogbones masked with electroplaters tape
- 0.25 in dia. hole, 0.75 inch dia. surface exposure each side of dogbone

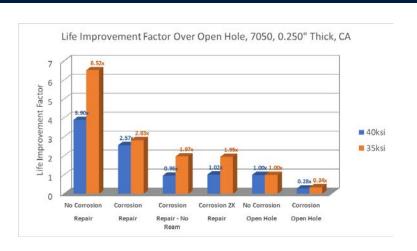
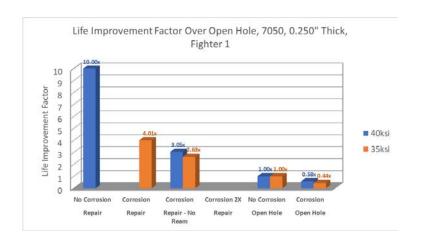
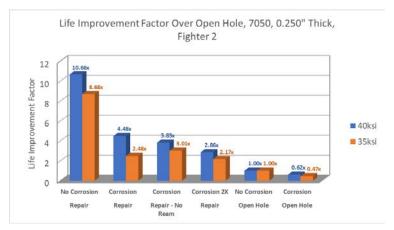
Baseline – open hole, no corrosion	
Corroded - open hole	
Repair - no corrosion	
Corroded, reamed repaired	
Corroded, reamed, repaired, corroded	
Corroded, repaired (no ream)

Repaired when new, cycle for 10K cycles, then corrode and cut coupon in half to look for potential corrosion between bore of hole and barrel of thin wall bushing

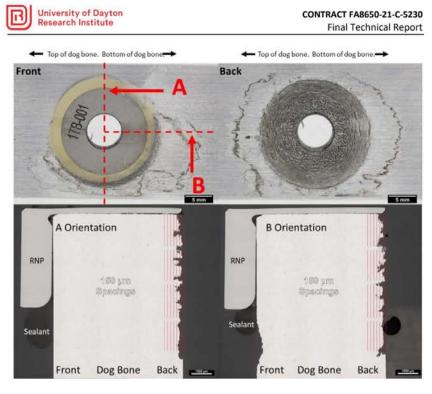
### Adhesive - Galvanic Barrier

7050 material – 120 hour corrosion protocol

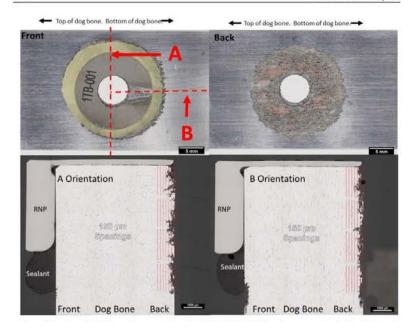
### Galvanic Barrier

2124 material - 120 hour corrosion protocol

The 120 hour corrosion of the repaired and corroded AA2124-T8151 dog bone exhibited no observable corrosion attack beneath the RNP-sealant/bore hole wall interface, except for attack from the surface undercutting the sealant on the front of the dog bone in both orientations as well as on the back of the dog bone at the RNP-Sealant/bore hole wall interface.
