# Reinventing the Future of Cold Expansion™

## Bolt Hole Corrosion and Fatigue Damage Repair in Hybrid Structure

Vertical Flight Society Forum 79  
Presented by Dale Manning  
May 2023

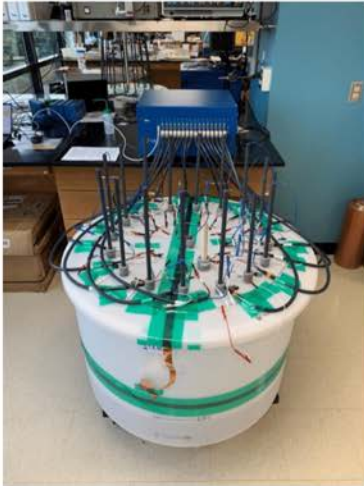
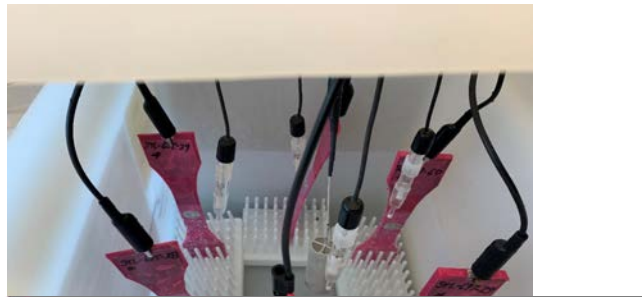
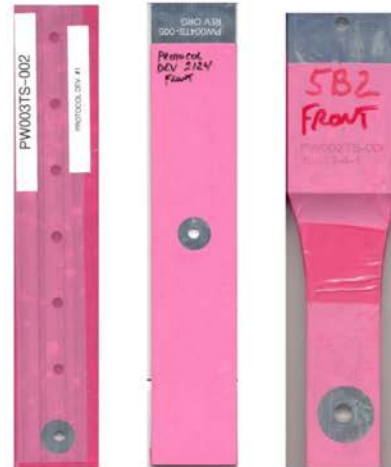
Figure 6 (L) Representative image of a multihole protocol development specimen taped off to expose one bore hole for corrosion testing; (C) Representative image of a single hole protocol development specimen taped off to expose one bore hole for corrosion testing; (R) Representative image of a dog bone fatigue test specimen taped off to expose the bore hole for corrosion testing (note: only top 2/3 of dog bone visible in scan image, although entire dog bone was taped).

- NaCl and NaAlO<sub>2</sub> solution
- Dogbones masked with electroplaters tape
- 0.25 in dia. hole, 0.75 inch dia. surface exposure each side of dogbone
- Solution biased at 700mV

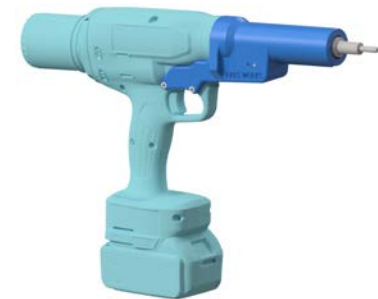
# Augmented Reality for Repair Tracking

- Record data real-time without operator intervention
- Validate correct hole repaired with right tooling/ fastener
- Simple set up with out complex calibration process
- Integrated scanning and mapping holes to database
- Compatible with phone/tablet/glasses/goggles

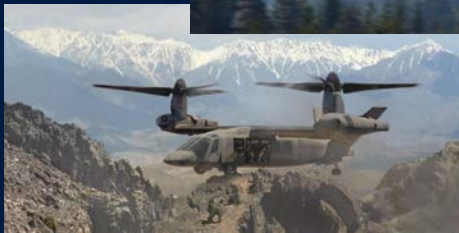
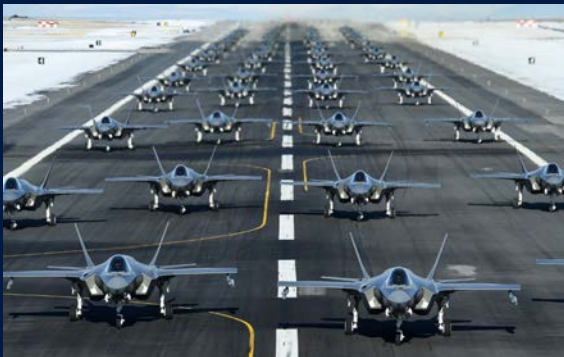
## Considerations for New Production

F-18 program spends \$690M / year on corrosion (30% of total maintenance budget)

Hybrid structure of some of the newest aircraft have similar corrosion problems

PartWorks' solution incorporated in new production can mitigate corrosion in fastener holes
