## Enhanced technology repair for corrosion and fatigue damage in hybrid aerostructure

Dr. Matthew Kokaly<sup>1</sup>, Mr. Jude Restis<sup>2</sup>

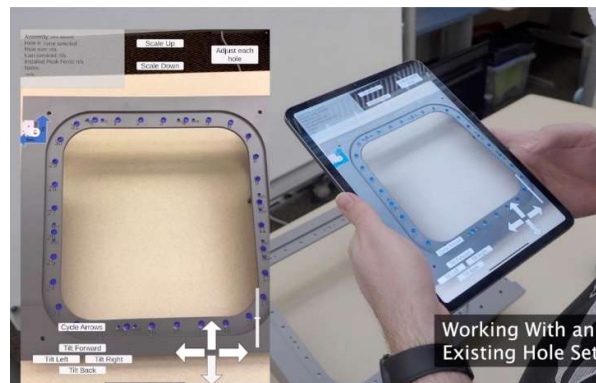
For the a second, more automated mode of operation, as seen in Figure 19 below, the system can read a data file or CAD model and pre-populatd the hole locations to be processed on the screen. The operator has an opportunity to correct any hole locations that may not have matched the database. The operator or mechanic can then continue with the repairs with the system tracking the processing of each hole and providing feedback for pass/fail to the operator.

Figure 19 Auotmatic Selection of Holes to be Processed using AR
