Enhanced Technology Repair for Corrosion and Fatigue Damage in Hybrid Aerostructure

AA&S 2024

Presented by Jude Restis

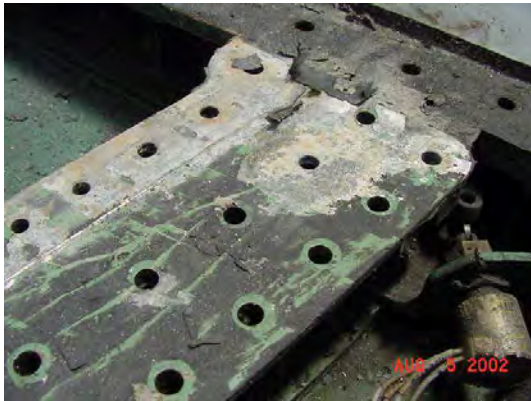
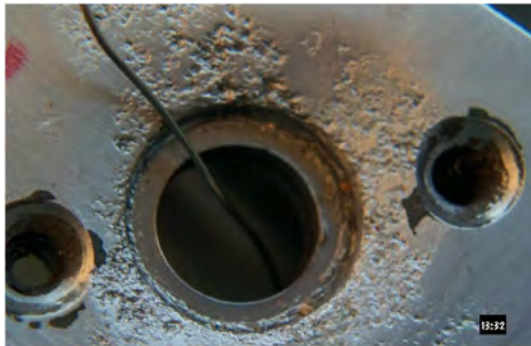
Widespread galvanic corrosion damage experienced on multiple programs with composite over aluminum in the presence of moisture

From “In-service Corrosion Issues in Sustainment of Navy Aircraft” briefing, R. Mendoza, Aug 2012

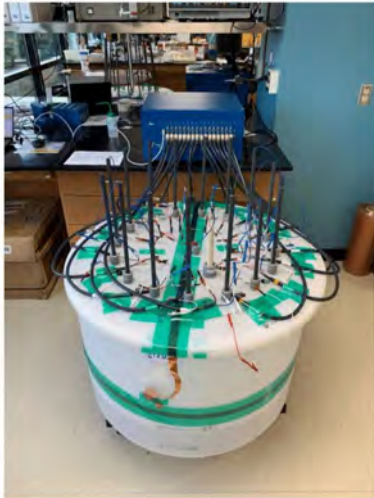
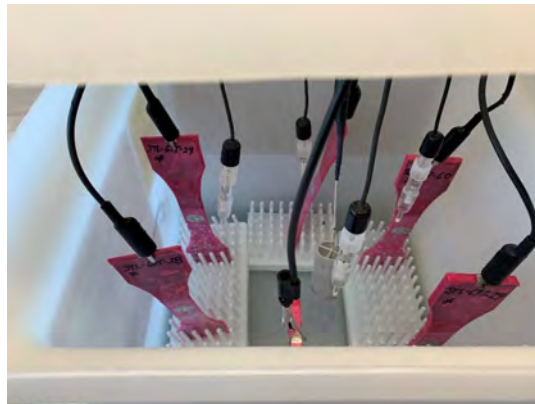
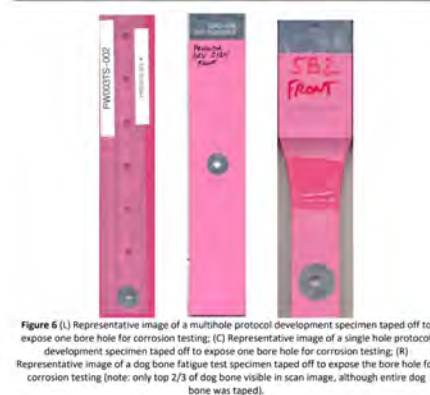
## Corrosion Protocol Development

- NaCl and NaAlO<sub>2</sub> solution
- Dogbones masked with electroplaters tape
- 0.25 in dia. hole, 0.75 inch dia. surface exposure each side of dogbone

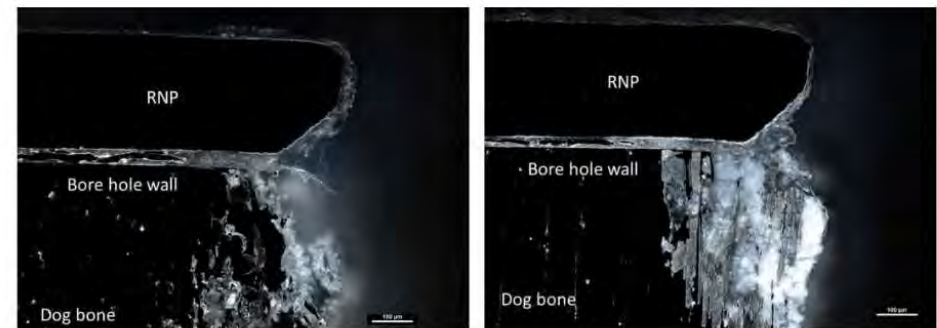
**Figure 24.** Dark field image of RNP-sealant/bore hole wall interface on back of dog bone. (Left) Orientation "A". (Right) Orientation "B".

2124 material – 120 hour corrosion protocol

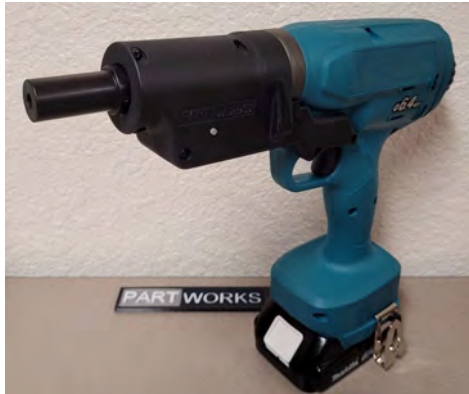
Handheld Puller with Process Control Electronics Incorporated

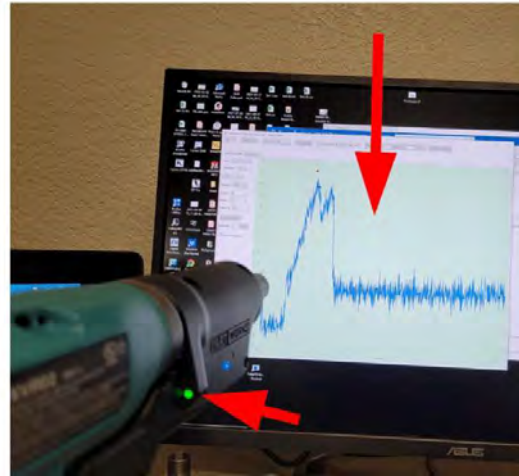
Process Control Software Identifying Successful Installation

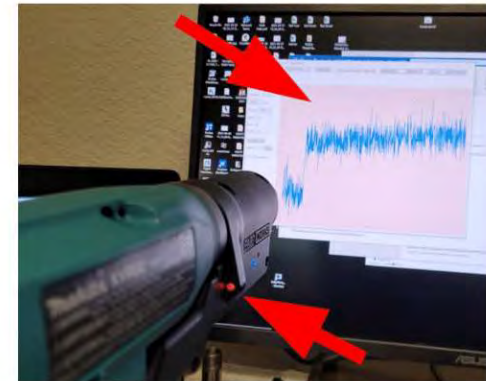
Process Control Software Identifying Unsuccessful Installation with LED and Red Graph

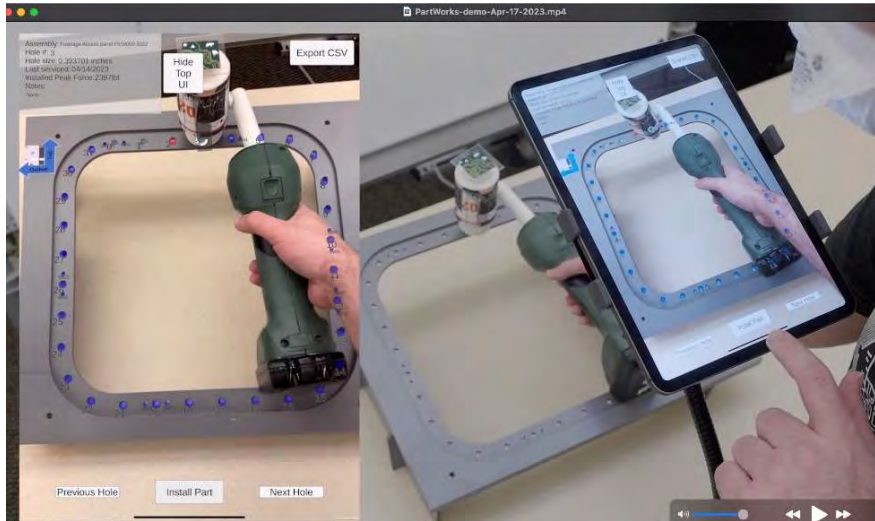
## Augmented Reality for Repair Tracking

- Record data real-time without operator intervention
- Validate correct hole repaired with right tooling/ fastener
- Simple set up with out complex calibration process
- Integrated scanning and mapping holes to database
- Compatible with phone/tablet/glasses/goggles
- X-ray view/Peel-away for parts where 3D model available (not required)

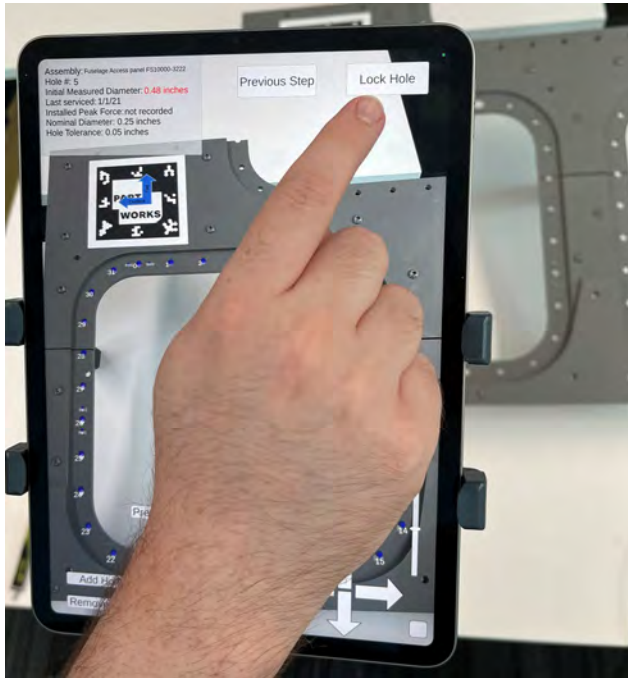
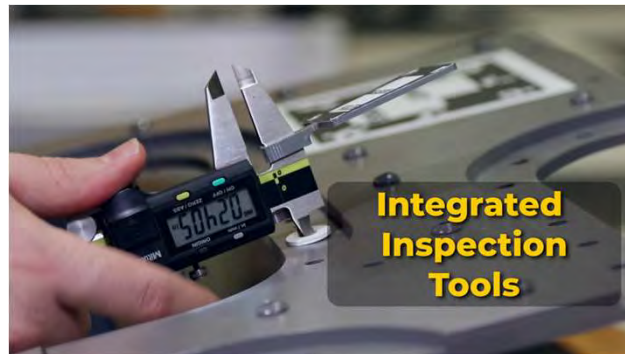
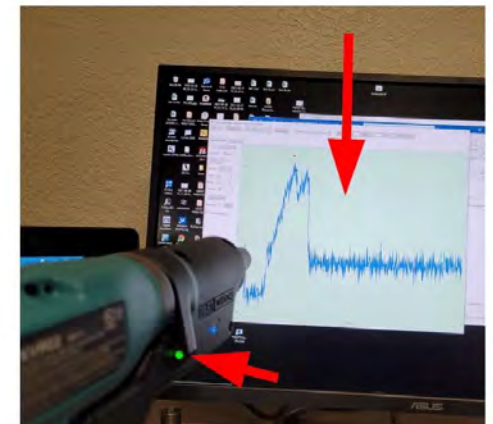
# What is Augmented Reality (AR)?

AR overlays digital content onto the real world in real-time, enhancing the user's perception of their environment.
